# Stream Crossings

## Effect on Fish, Wildlife & Water Quality

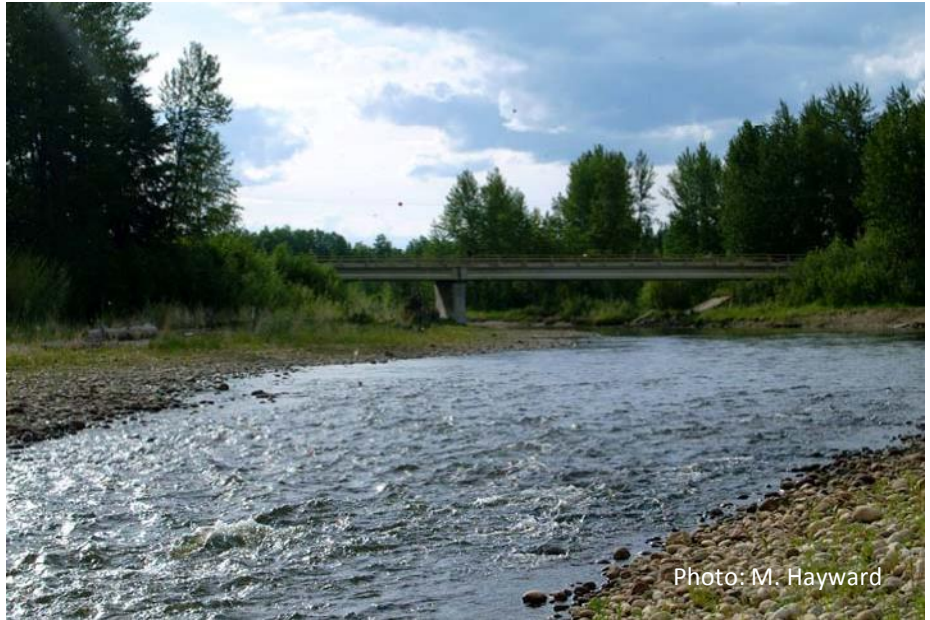
Photo: M. Hayward

*A bridge maintains the connectivity of a stream and most of its riparian corridors ensuring uninterrupted fish and wildlife passage through it.*

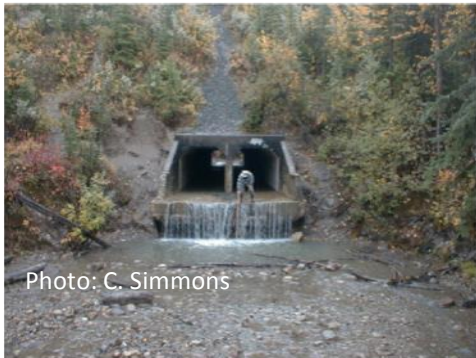
Photo: C. Simmons

Another important factor to consider is the maintenance of the connectivity of the stream's **riparian corridors** to allow uninterrupted **passage of wildlife** that rely on riparian habitat. Structures should provide for safe passage of animals that otherwise would have to cross over the road with the risk of collision with vehicles. Roads with heavy traffic discourage some animal species from crossing and thereby isolate populations which is unhealthy for the maintenance of genetic diversity and the perpetuation of the species.

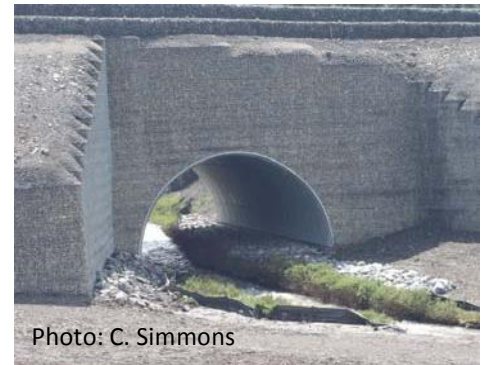
Photo: C. Simmons

*New arch culvert with silt fences and narrow bands of naturally re-established vegetation.*

Active or recent soil excavations and construction of stream crossing structures, can result in **sediments** and/or **contaminants** entering a stream. This problem can be minimized by installing proper mitigation practices to control runoff, erosion and sedimentation (examples: silt fences, check dams, structural mats, etc.) combined with active re-vegetation.

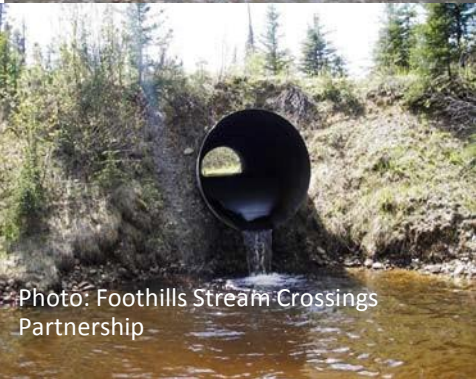
Photo: Foothills Stream Crossings Partnership

*Culvert bottom placed above the stream bed disrupts fish passage. Too narrow or too wide culverts change the stream's velocity and/or water depth.*

tributaries to find mates, spawn, grow, find food, and find a resting place. Fish require certain stream flow velocities at different stages of life. Changes in water depth affect several stream physical properties (example, water temperature) and many biological processes (example, survival of aquatic and riparian plants).
